# Evaluating the impact of the Churches Conservation Trust model for investment in Condition, Maintenance and Repair for historic places of worship

## Historic England

Final report  
27<sup>th</sup> March 2015

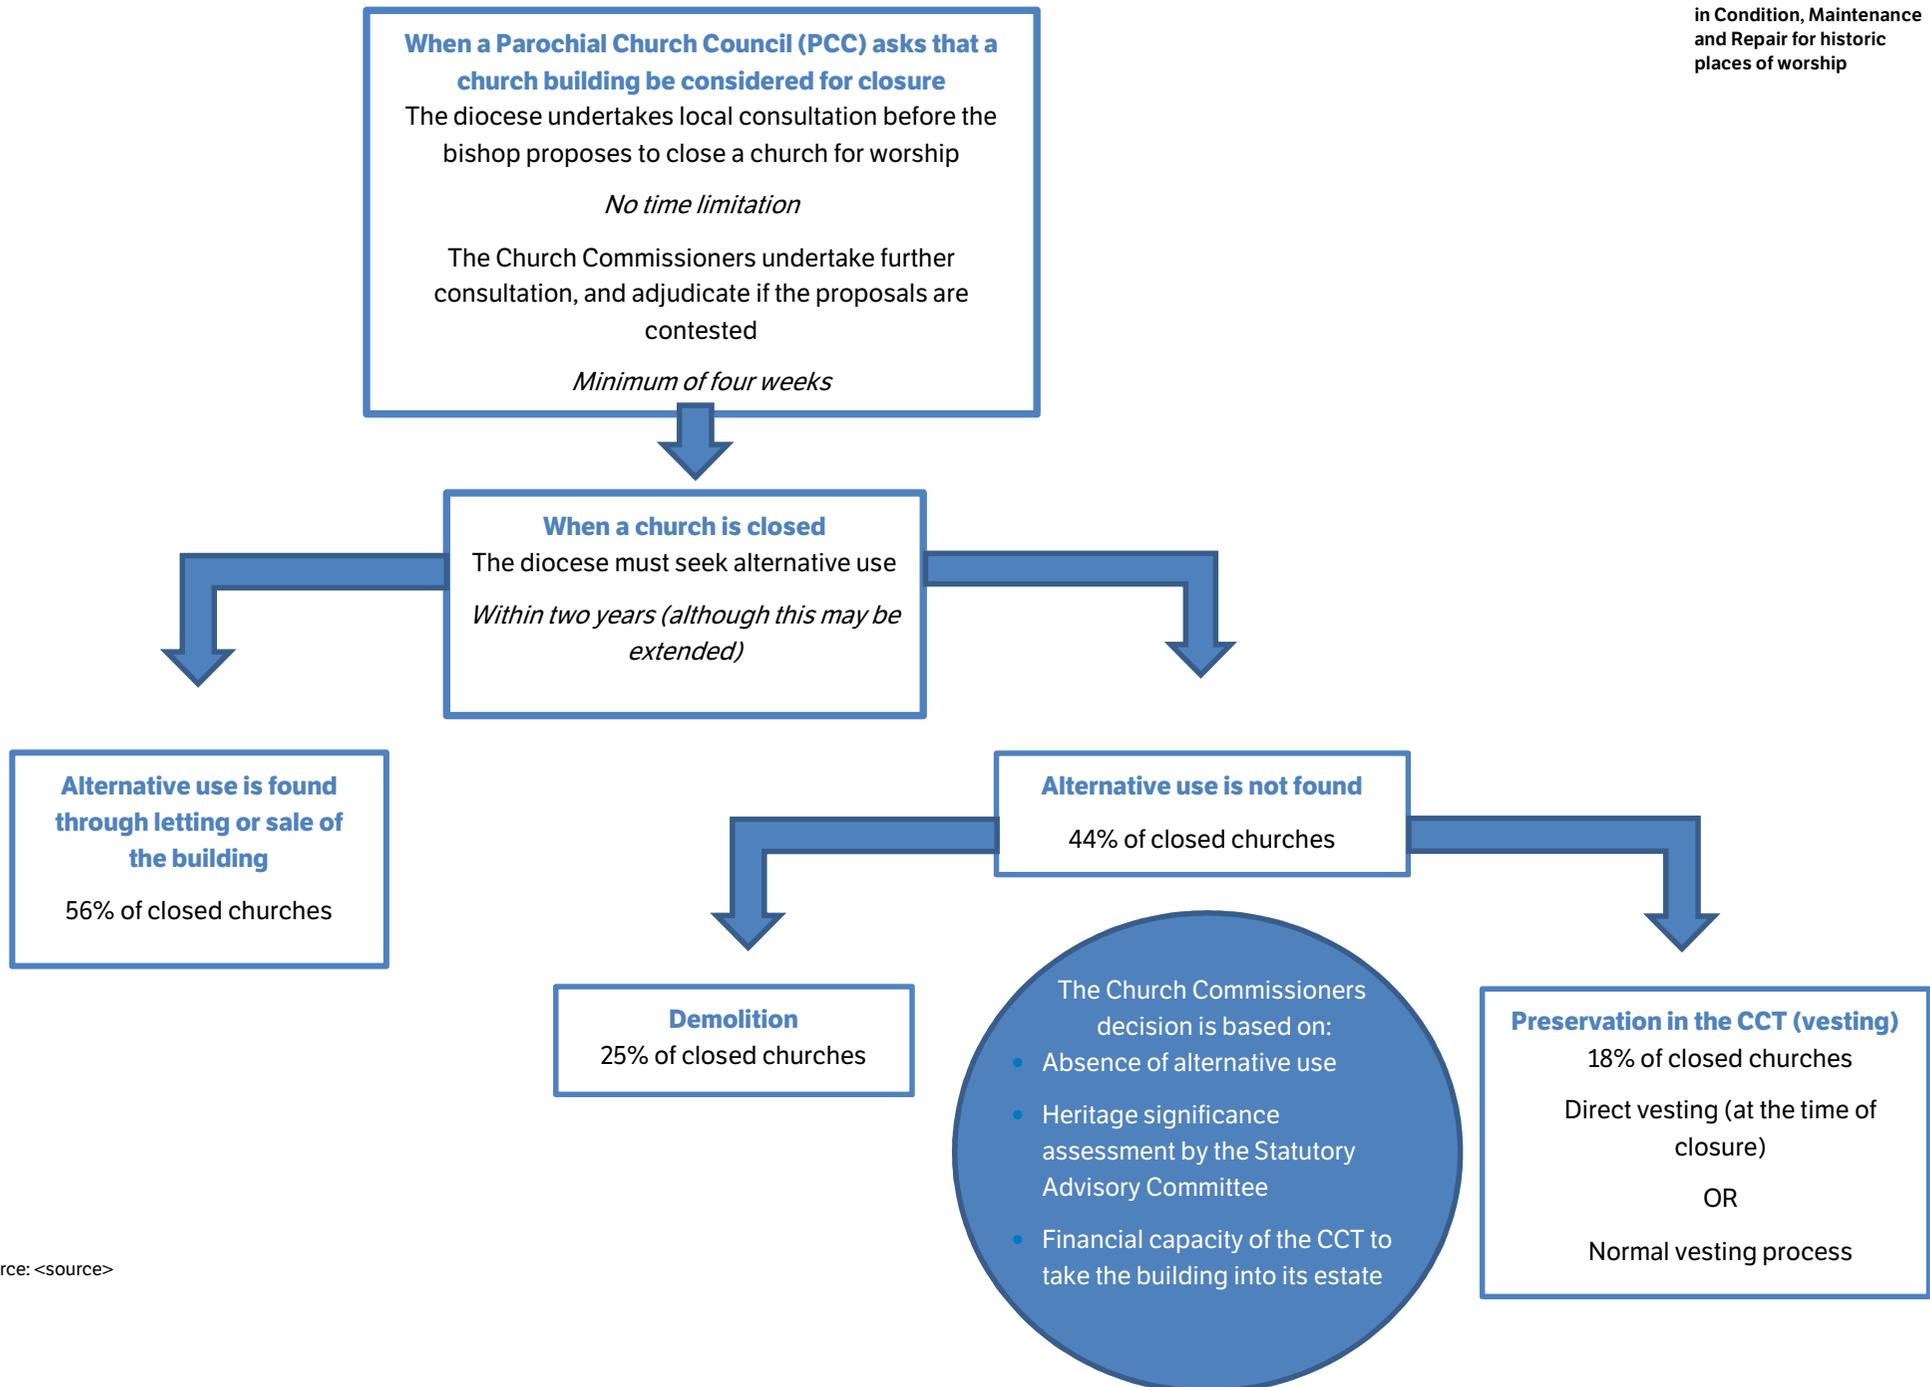
Figure 2 Decision process from closure to vesting

- First, the Church Commissioners (CC) must concur with the Parochial Church Council’s (PCC) and dioceses’ view that the building should be formally closed for worship and that no alternative use is possible;
- Following consultation with their statutory advisors, the statutory advisory committees of the Church Buildings Council, that the building is of such merit that it ought to be preserved;
- Following consultation with the CCT, that the latter will have the resources to repair and maintain it.

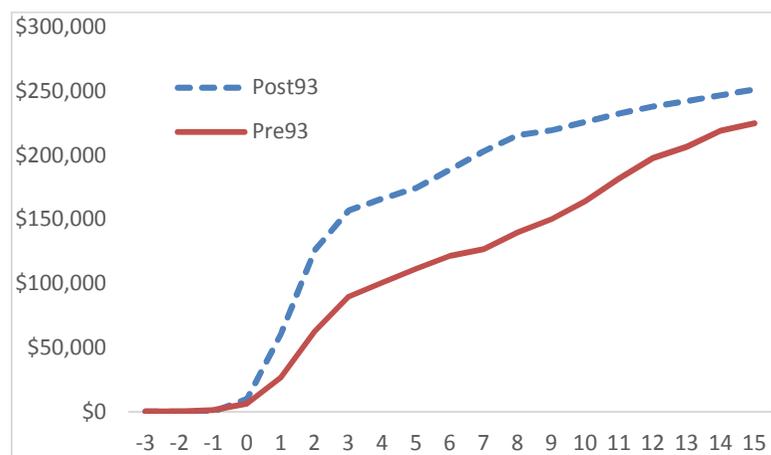
**Figure 9 Average cumulative CCT expenditure per year since vesting (in real £), for a 15-year period, by management model, 2014**

One of the more important research questions is to understand if the upfront higher cost in the post '93 management model translates into net savings in the long term.

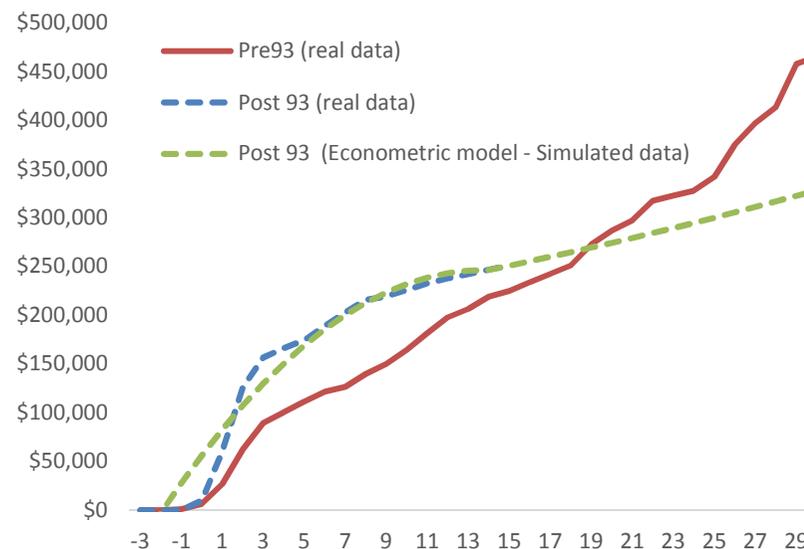
**Figure 10 Average cumulative CCT expenditure per year since vesting (in real £) with simulated data, for a 30 year period, by management model, 2014**

Ideally, we would conduct the same analysis over a longer time period. However, as noted previously, the time limitations of our dataset – i.e. the oldest church under the post '93 model has only been vested for 20 years – means that this is not straightforward.

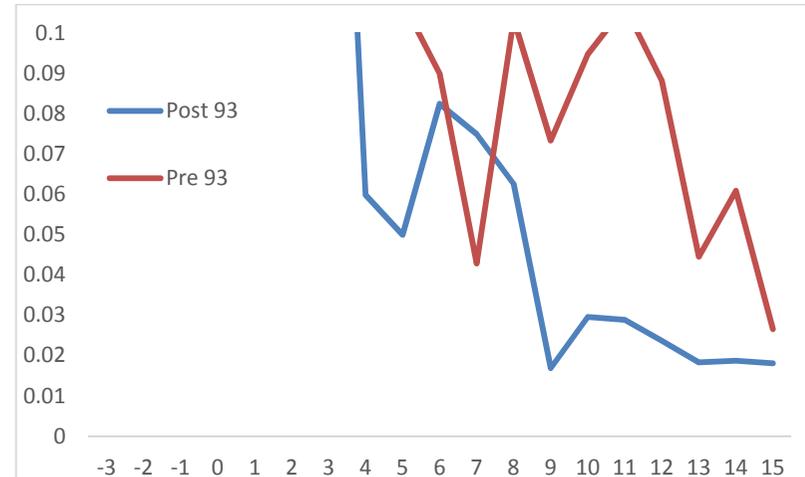
**Figure 48 Total expenditure % growth (year-on-year)**

The hypothesis of a constant 1.8% growth is derived from the chart below. The total expenditure for the post '93 period seems to have settled around 1.8%. Thus, the previous chart presents an adapted version where after the econometric model reaches its peak, it grows at a long term rate of 1.8% a year.
