Historic England

# Church Roof Replacement Using Terne-coated Stainless Steel

Guidance Note

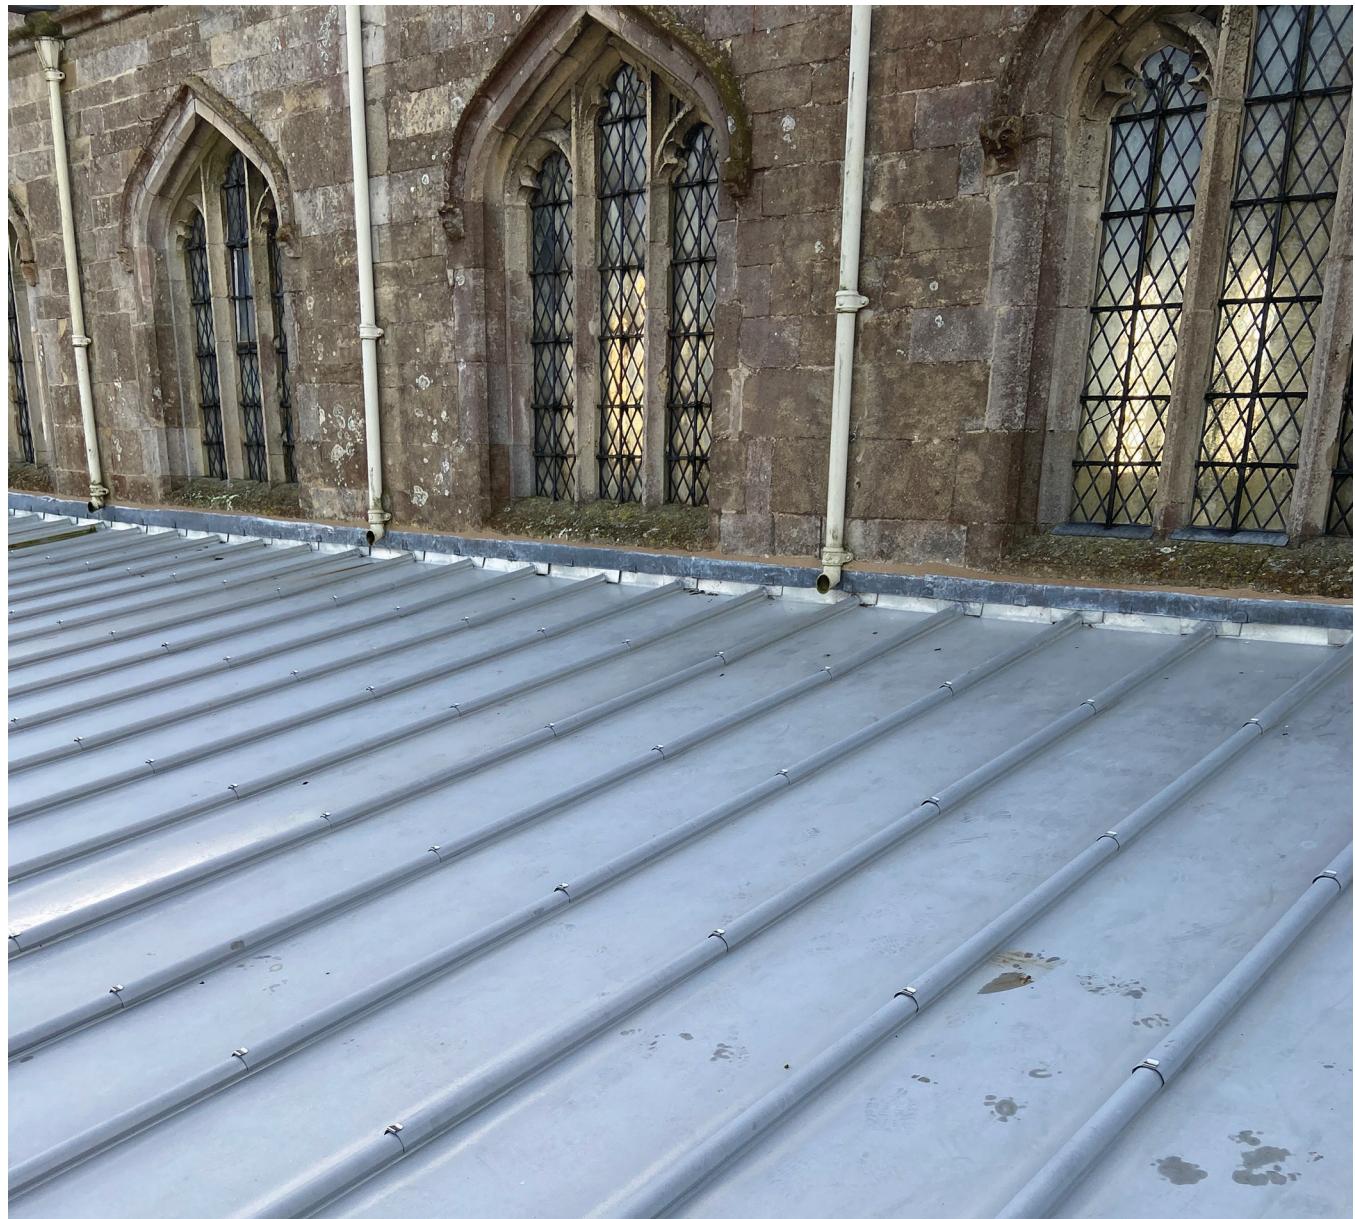
**Front cover:**  
Terne-coated  
stainless steel  
roof with round  
batten rolls ©  
Steve Bevins

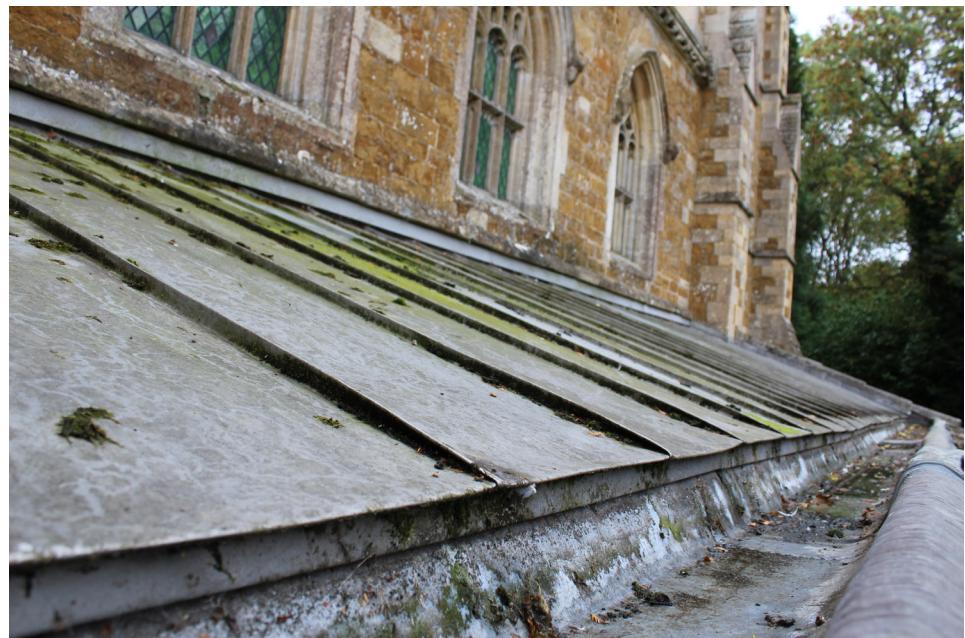
Figure 1:  
Standing seams

The 25mm high standing seam has a double-welted top. The minimum finished slope for this type of joint is 5°. In some exposed locations with long shallow slopes, water has found its way through the seams by capillary action or potentially by wind and thermal pumping action. This phenomenon is a result of wind pressure and temperature changes on partially sealed seams. Many contractors now apply a butyl seal within the seam before closing up. However the seal, which is inaccessible once the roof is properly formed, can have a relatively short life expectancy of typically 10 years.

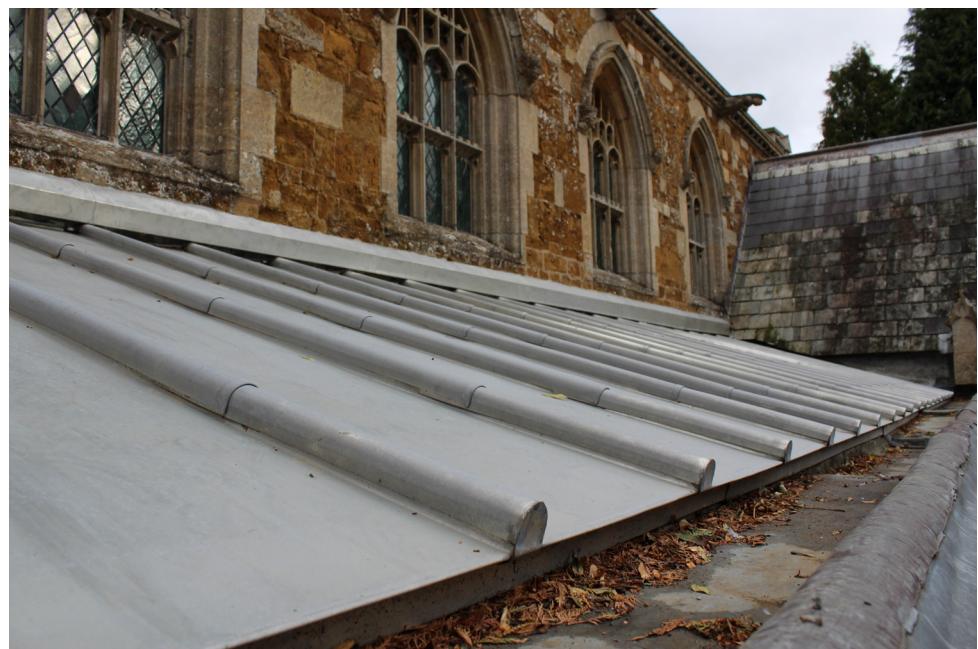
Figure 2: Round-  
batten rolls

The alternative method of forming a side joint is to use a batten roll detail. The minimum finished slope for this type of joint is 3°. The sides of each stainless steel pan are dressed up the sides of a 50 x 50mm shaped timber batten. The up-turns at the sides of the panels are 40mm high, so there is less risk of rainwater entry than with a standing steam, whilst allowing the joint to breathe. The batten and up-turns are then protected with a separate stainless-steel capping strip dressed to shape and fitted over the batten.

Battens can be formed in different shapes. The round batten roll closely resembles the traditional lead roll. An alternative preferred by some architects is a square batten with the capping held in place with welted edges, although this does not replicate the appearance of a traditional lead roll.

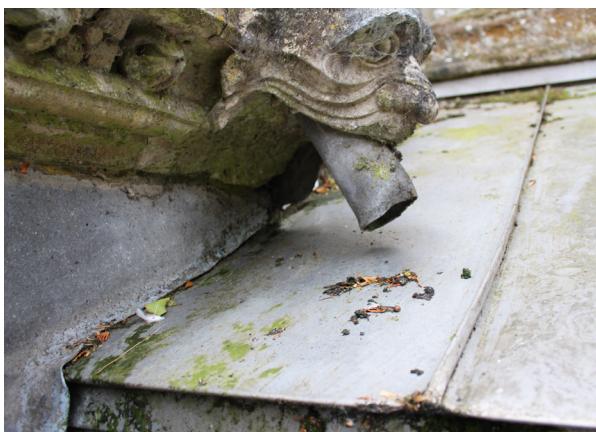
Figure 3:  
Awkward detail  
at verge with  
water running  
into upstand

Some rainwater ingress has been observed at verges and below sloping valleys where it has not been possible to form and dress irregular-shaped panels in stainless steel on site. This could be resolved by preparing a special panel in a workshop. Alternatively, for relatively small areas, the detail work around roof edges could be formed in lead. Although this could be attractive to a thief, on a typical roof more than 95 per cent of the roof covering would still be formed in the terne-coated stainless steel and at very low risk of theft.

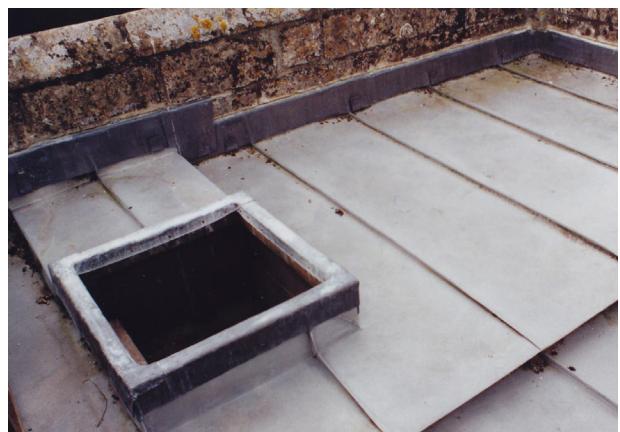
Figure 4:  
Lead used for  
flashings and  
access hatch  
capping

Other awkward details such as around pipe penetrations and access hatches could also be formed in lead. Lead remains the preferred material for flashings dressed into masonry. Where possible, standard details should be adopted and agreed in advance.

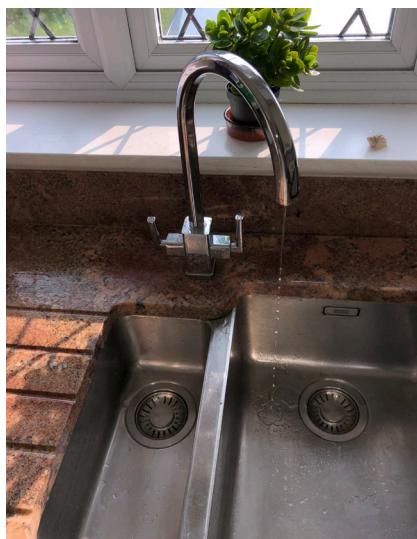
Figure 5: Water dripping into a stainless steel sink

The alternative is to use a thicker solid strip that is factory adhered to the underside of the flat pan of the roofing. This uses the same technique as that used to reduce the noise of drops of water from a dripping tap falling into the bowl of a stainless steel sink. The mat bonded to the underside increases the stiffness of the metal, reducing the impact sounds.

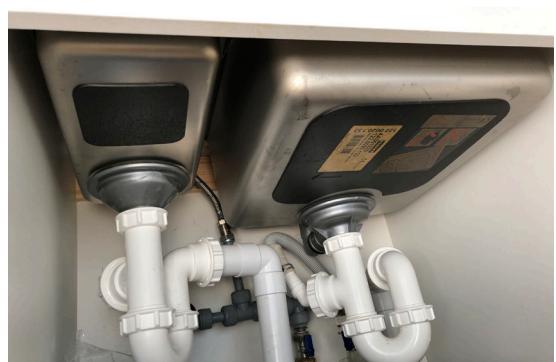
Figure 6: Mats bonded to underside of sink to reduce dripping noises

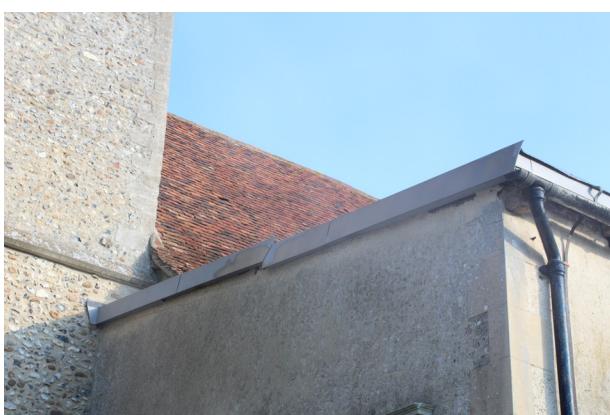
Figure 7:  
Straight verge  
fascia contrasts  
with uneven  
masonry

On occasion perimeter detailing to the stainless steel roofing can be readily seen from ground level and if not properly considered can create an unacceptable appearance.

Care is required in considering perimeter details that can be seen from ground level. Alternative details using traditional materials such as stone or rendered masonry may be feasible. Alternatively, forming the verge in lead could be considered, although again this could be attractive to a potential thief.

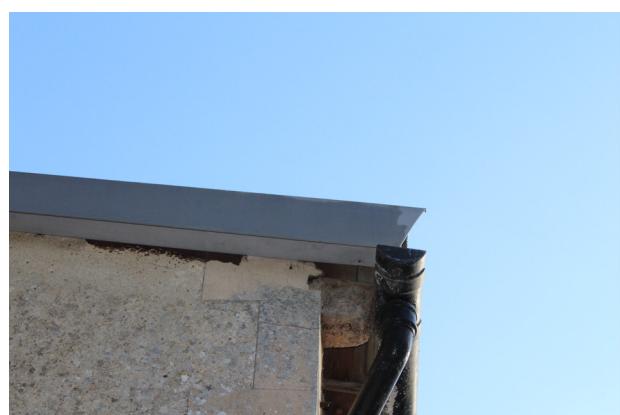
Figure 8: End of  
fascia with  
acute corner  
and incomplete  
closure

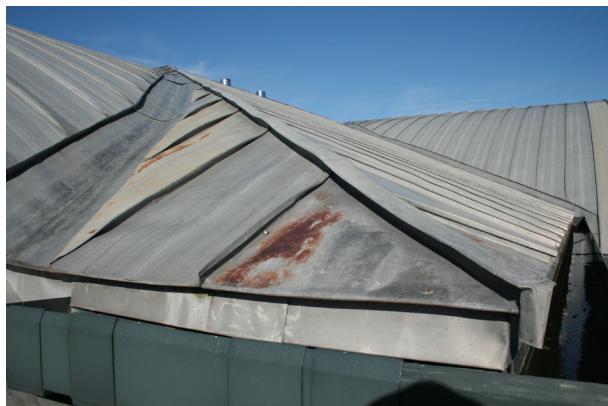
**Figure 9:**  
Discolouration  
of lead-rich  
terne-coated  
stainless steel

On a few stainless steel roofs with the old lead/tin terne coating, a brown-coloured residue formed after several years of exposure. On investigation it was found that there was no reduction in the overall thickness or pitting corrosion in the stainless steel roofing. Trials have shown that the discolouration can be permanently removed using a weak phosphoric acid solution that is commonly found in carbonated soft drinks, especially cola.

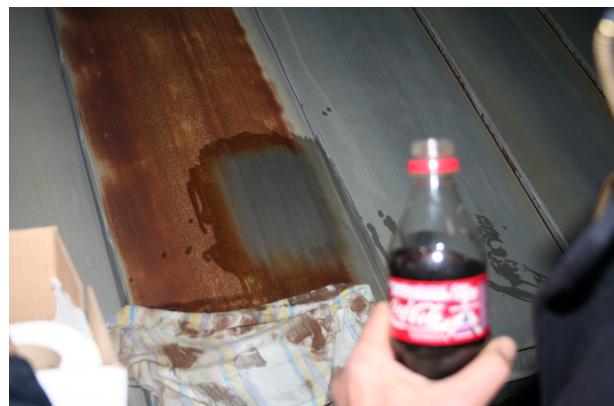
**Figure 10:** Stain  
successfully  
removed using  
weak phosphoric  
acid solution
