# Church Roof Replacement Using Terne-coated Stainless Steel

Guidance Note

HEAG 280

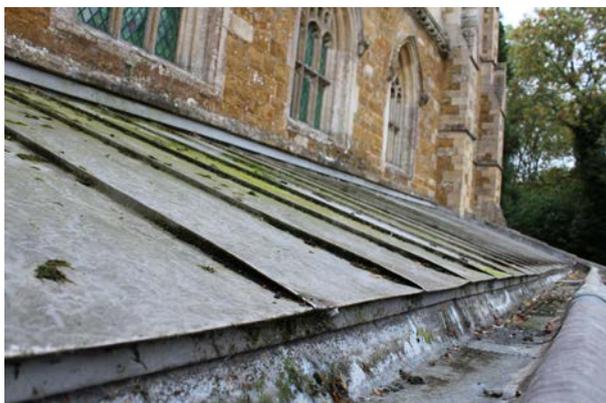
Standing seams

The 25 mm high standing seam has a double welted top. The minimum finished slope for this type of joint is 5°. In some exposed locations with long shallow slopes water has found its way through the seams by capillary action or potentially by wind and thermal pumping action. This phenomenon is a result of wind pressure and temperature changes on partially sealed seams. Many contractors now apply a butyl seal within the seam before closing up. However the seal, which is inaccessible once the roof is properly formed, can have a relatively short life expectancy of typically 10 years.

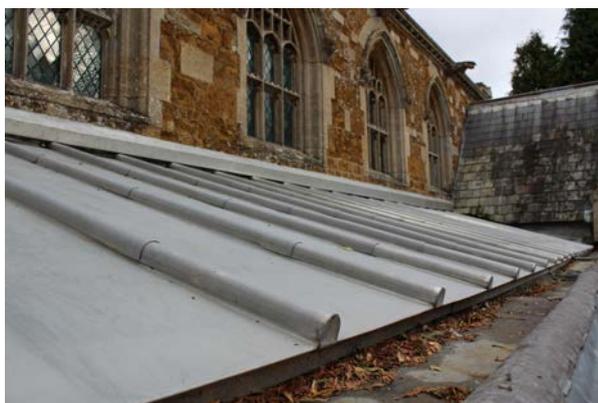
Round-batten rolls

The alternative side joint is to form a batten roll detail. The minimum finished slope for this type of joint is 3°. The sides of each stainless steel pan are dressed over a 50 x 50 shaped timber batten. The sides are 40 mm high with less risk of rainwater entry, whilst allowing the joint to breathe. Battens can be formed in different shapes. The round batten roll with a stainless steel cap batten closely resembles the traditional lead roll. An alternative preferred by some architects is a square batten with the capping held in place with welted edges, although this does not replicate the appearance of a traditional lead roll. Stainless steel cleats hold the sheets down and prevent detachment of the lightweight material in strong winds. The means of attachment also allow long lengths of sheet metal to expand and contract along the length of the roof slope. As there is less work hardening in forming the seams the risk of creating unevenness in the flat pan of the sheet, known as quilting or oil canning, is reduced.

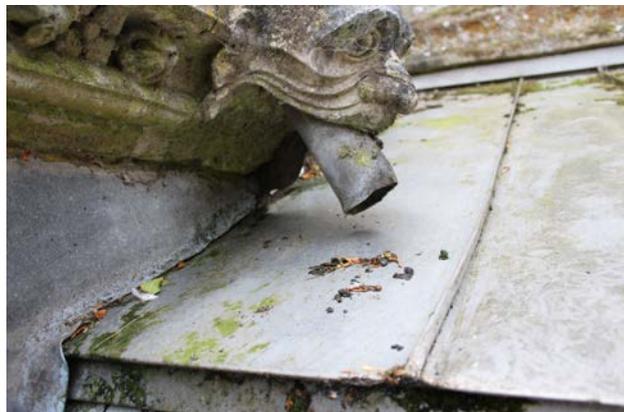
Awkward detail at verge with water running into upstand

Some rainwater ingress has been observed at verges and below sloping valleys where it has not been possible to site form and dress irregular shaped panels in stainless steel. This could be resolved by preparing a special panel in a workshop. Alternatively for relatively small areas the detail work around roof edges could be formed in lead. It is recognised that this could be attractive to a thief, although on a typical roof more than 95% of the roof area would still be formed in the terne coated stainless steel.

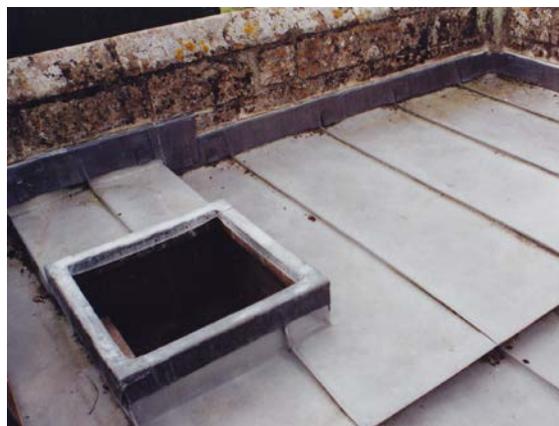
Lead used for flashings and access hatch capping

Other awkward details such as around pipe penetrations and access hatches could also be formed in lead. Lead remains the preferred material for flashings dressed into masonry. Where possible standard details should be adopted and agreed in advance.

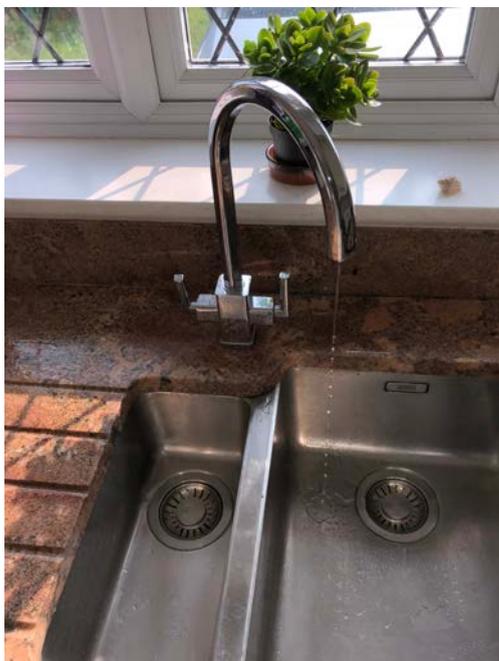
Water dripping into a stainless steel sink

The alternative is to use a thicker solid strip that is factory adhered to the underside of the flat pan of the roofing. This uses the same technique as that used to reduce the noise of drops of water from a dripping tap falling into the bowl of a stainless steel sink. The mat bonded to the underside increases the stiffness of the metal, reducing the impact sounds.

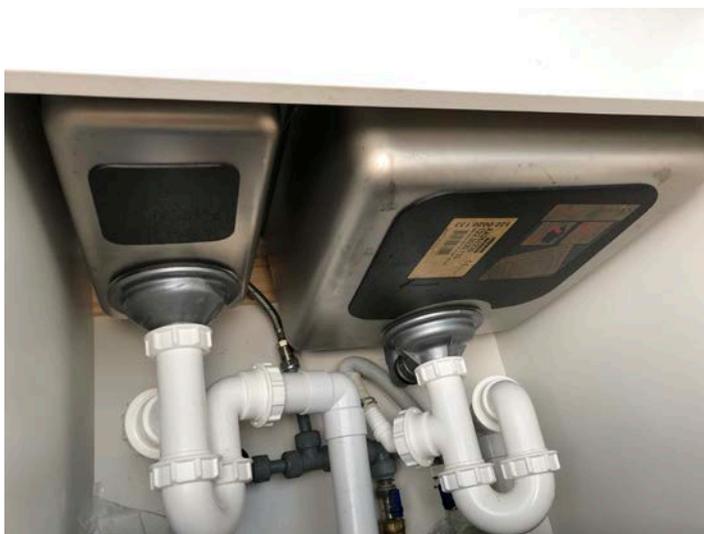
Mats bonded to underside of sink to reduce dripping noises

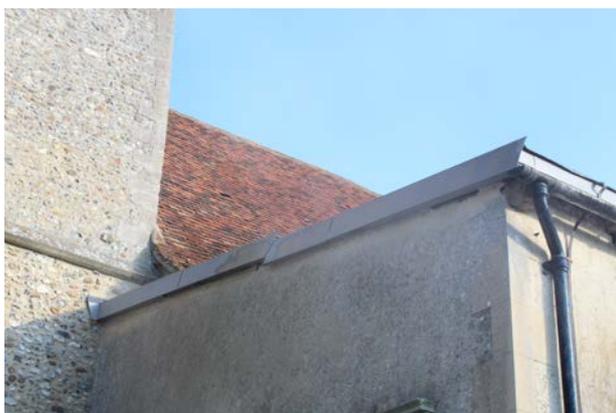
Straight verge fascia contrasts with uneven masonry

On occasion perimeter detailing to the stainless steel roofing can be readily seen from ground level and if not properly considered can give an unacceptable appearance.

Care is required in considering perimeter details that can be seen from ground level. Alternative details using traditional materials such as stone or rendered masonry may be feasible. Alternatively forming the verge in lead could be considered, although again this could be attractive to a potential thief.

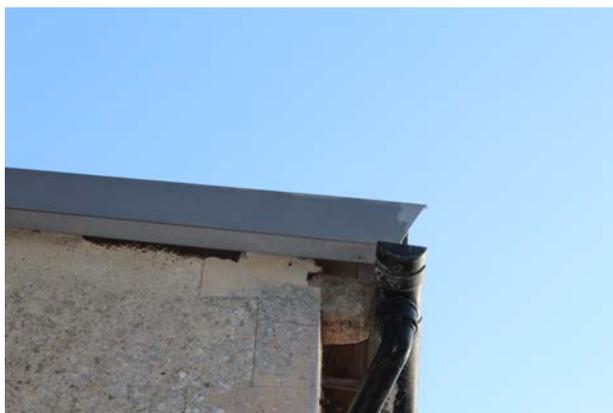
End of fascia with acute corner and incomplete closure

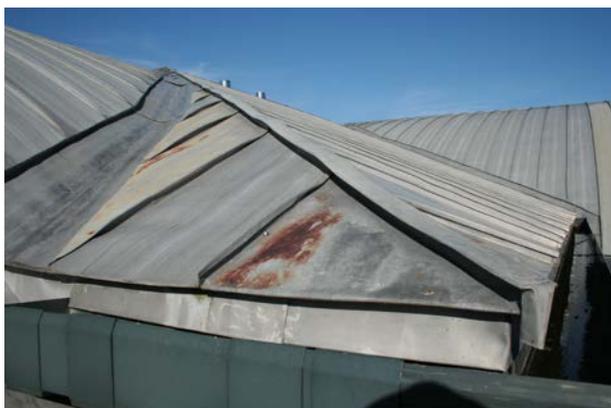
Discolouration of lead rich terne coated stainless steel

On a few stainless steel roofs with the old lead / tin terne coating a brown coloured residue formed after several years of exposure. On investigation it was found that there was no reduction in the overall thickness or pitting corrosion in the stainless steel roofing. Trials have shown that the discolouration can be permanently removed using a weak phosphoric acid solution that is commonly found in carbonated soft drinks, especially cola.

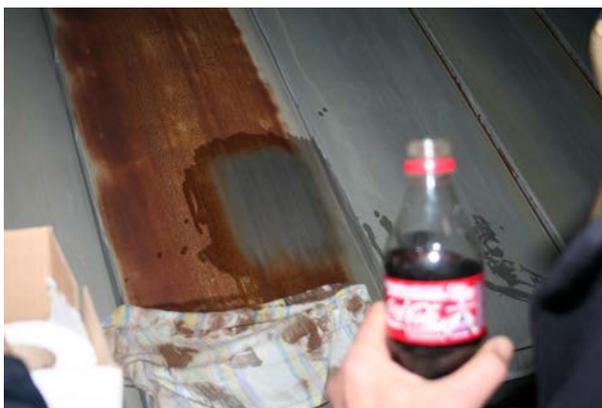
Stain successfully removed using weak phosphoric acid solution
