The Value of Maintenance?

Project Report

Compiled By: James Phillips BA(Hons), BArch, RIBA CA
Date of Report: 29/03/2019
Revision: 3

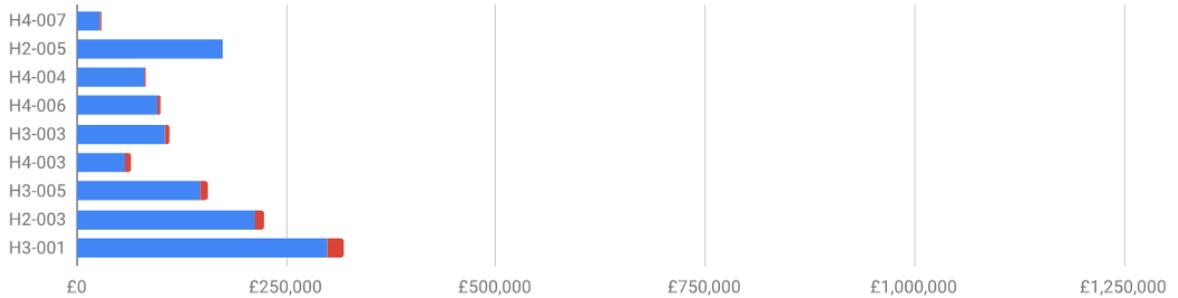
Figure 29 – Cumulative Cost of Delayed Repair – 9 churches with regular maintenance/repair

■ Initial cost of repair ■ Increase in cost as a result of a lack of timely repair

6.2.3. Figures 28 and 29 compare the initial cost of defects with the final cost, where change in cost was purely associated in worsening condition as a result of the lack of timely maintenance and repair. This increase in cost is shown in red on these graphs. At a basic level, this increase was all avoidable cost, though obviously available resources and funding do limit what is possible. This is why even the well maintained churches have sums of cumulative cost. However, it is clear that, when reviewing the percentage of the initial cost, churches where minimal maintenance and repair was carried out experienced much greater increase in cost liability as a result of not carrying out work in a timely fashion.

6.2.4. These graphs only demonstrate part of the cost associated with delaying repair. The costs shown on the graphs are the totals of cumulative costs of delay for individual items in isolation. For example, this may be that the initial cost was for a small amount of slipped slates, which by the end had increased as the number of slipped slates increased due to lack of repair. What it doesn't account for, however, is the consequential damage as a result of this, e.g. a plaster ceiling collapsing as a result of water ingress through these slipped slates. This is difficult to quantify on a cause and effect basis, as many issues have numerous causes. However, it was clear from the text of the QIRs that this consequential damage does occur and so the overall cost impact of delaying repair can be considerably greater than demonstrated on the previous graphs and can indeed be many times the cost of the original repair. The impact is best demonstrated by the overall increase in cost of the total cost liability of a church over the study period.
