Historic England

Stained Glass Windows

Managing Environmental Deterioration

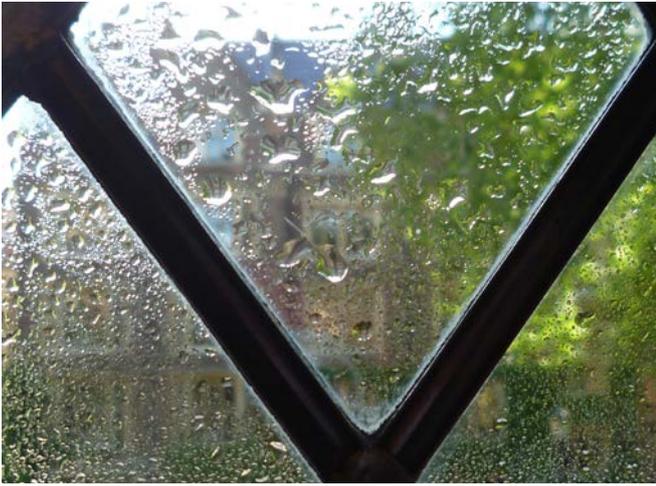
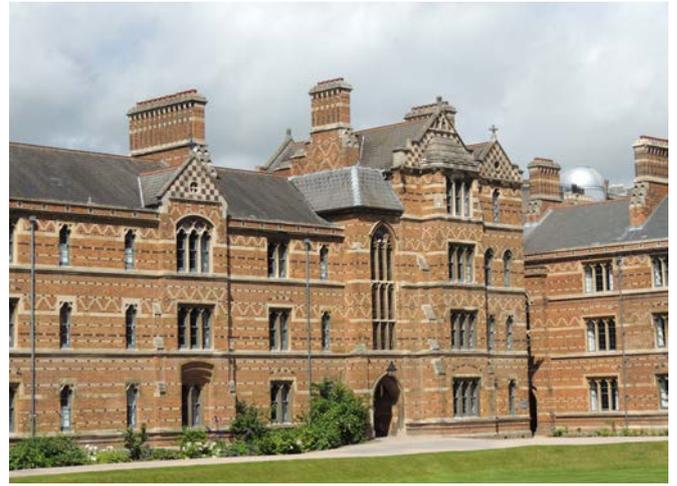
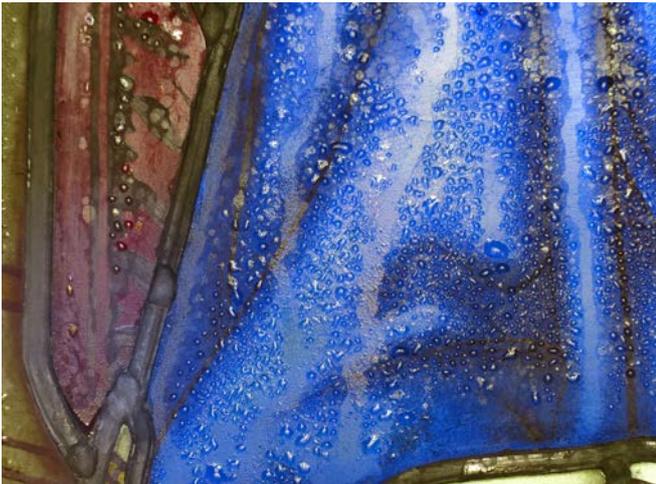
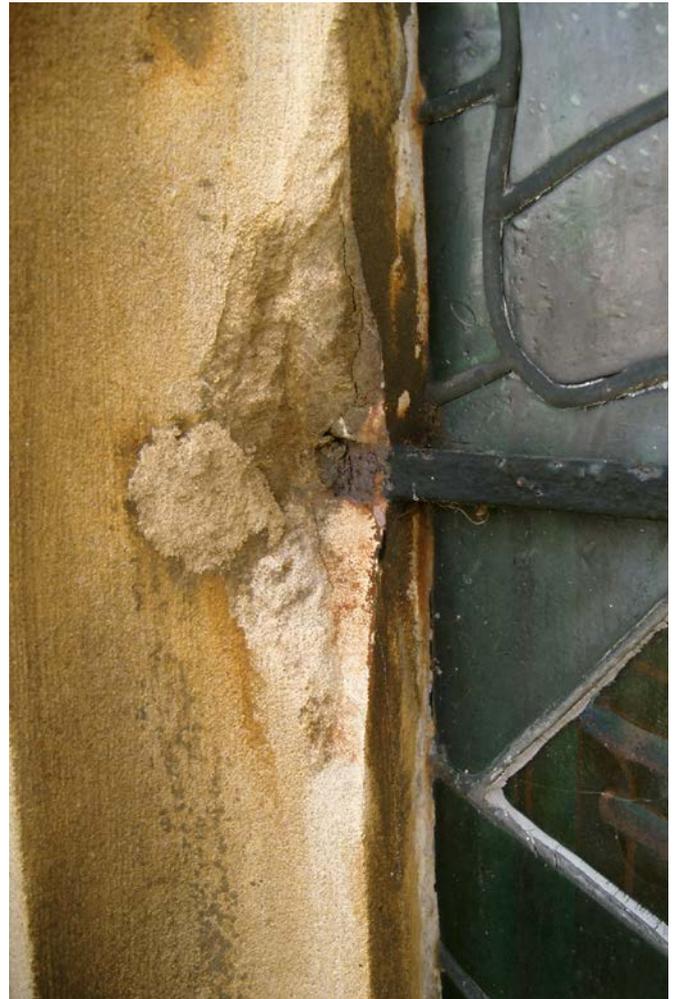
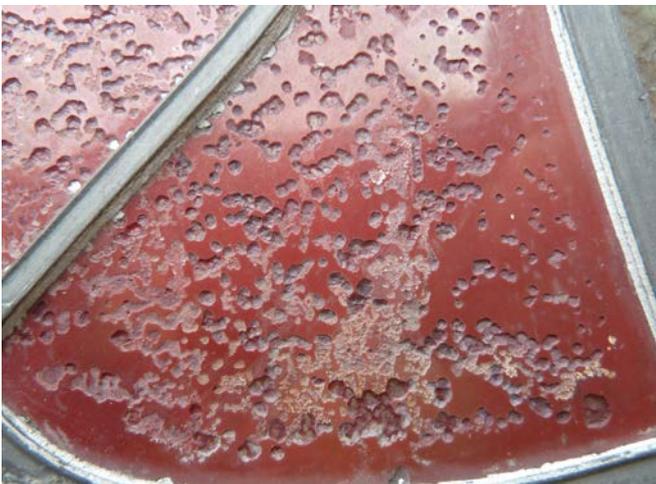
Figures 7–11: Sources of moisture.

Since glass, metal and glazing cements are all impermeable, rain hitting a stained glass window will run down, collecting into a flow that will then be quickly drawn in through any open joints or fine cracks (top left). Traditional building detailing (such as string courses and hood mouldings) were developed alongside glazing to divert rainwater running down the façade, reducing the amount of water reaching the glass (top right).

Glass and metal both transfer heat very easily, so when glazing is cooled by the wind and outdoor temperatures, it can easily lead to condensation on the interior of the window, especially if the building is damp (middle left). Whatever its source, water is critical to many types of deterioration, including pollutant attack, microbial growth, corrosion of the glass and the lead matrix (bottom left), and corrosion of metal components such as iron ferramenta and unprotected grilles. Rust can severely damage the stone in which the corroding iron is embedded (bottom right).

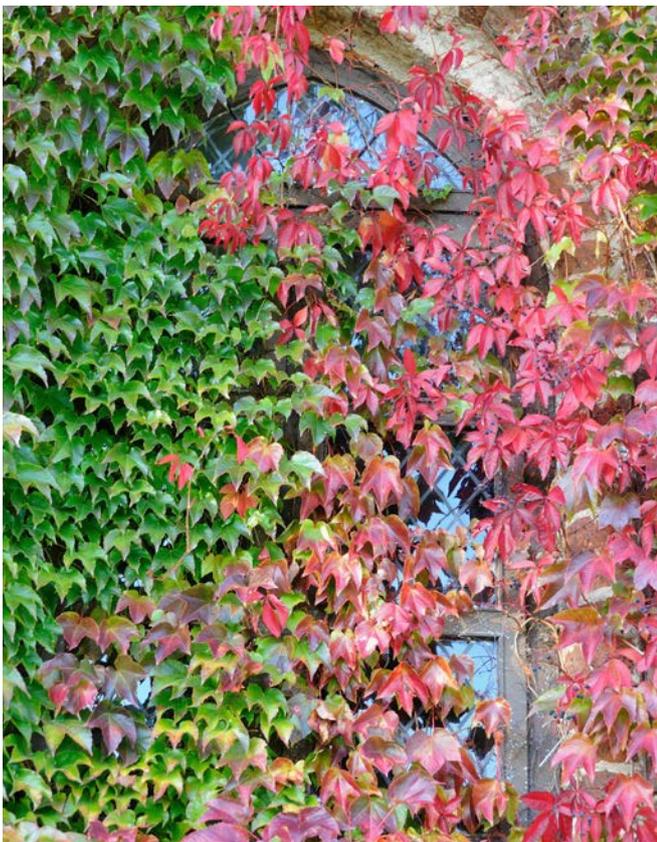
Figures 13–14: Risk of physical damage. The environment around the building may also increase the risk of breakage, which is very serious for glass. Left: Plants should be kept away from the glass, and nearby trees assessed regularly to ensure there is no risk from branches. Right: Projectile damage may be the result of mowing or strimming nearby without sufficient care. Deliberate vandalism is a very serious risk in certain locations, and becomes more likely whenever the building does not look sufficiently well cared-for.

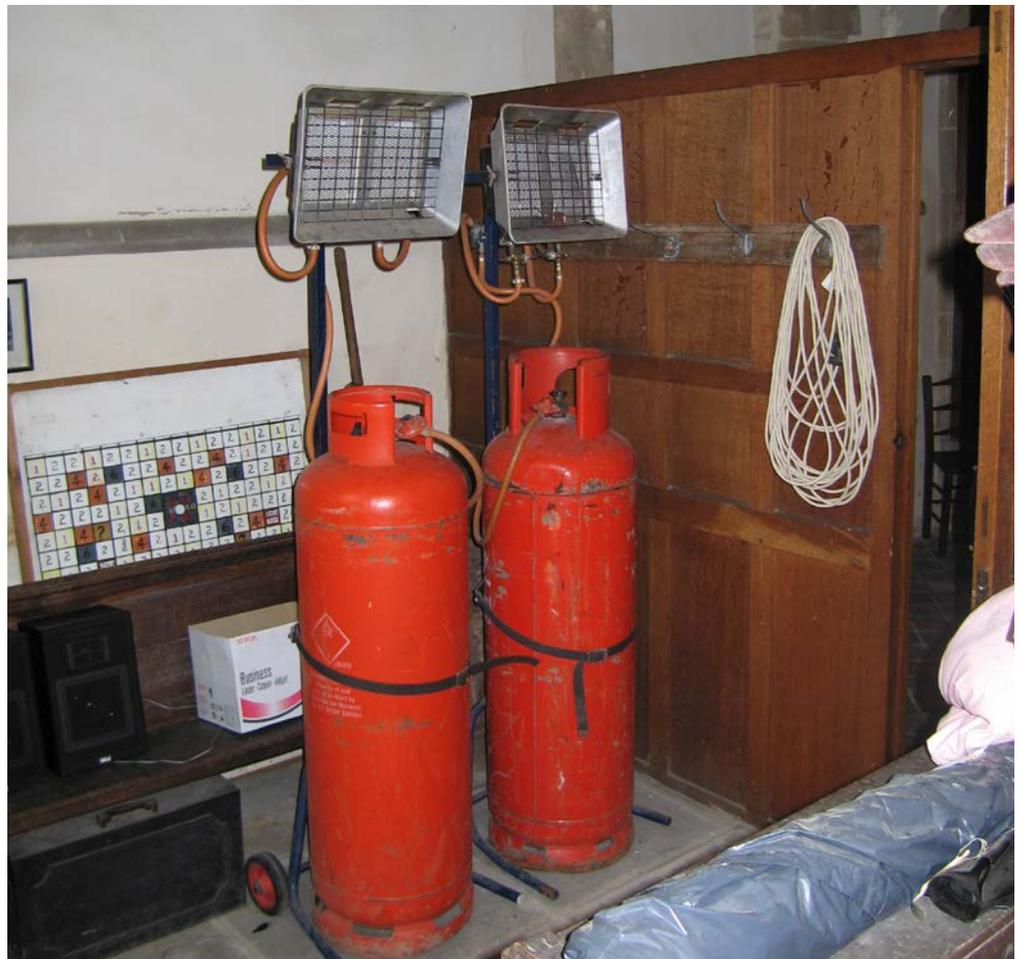
Figure 18: Heaters running on bottled gas are a serious source of indoor moisture, adding to the risk of condensation.

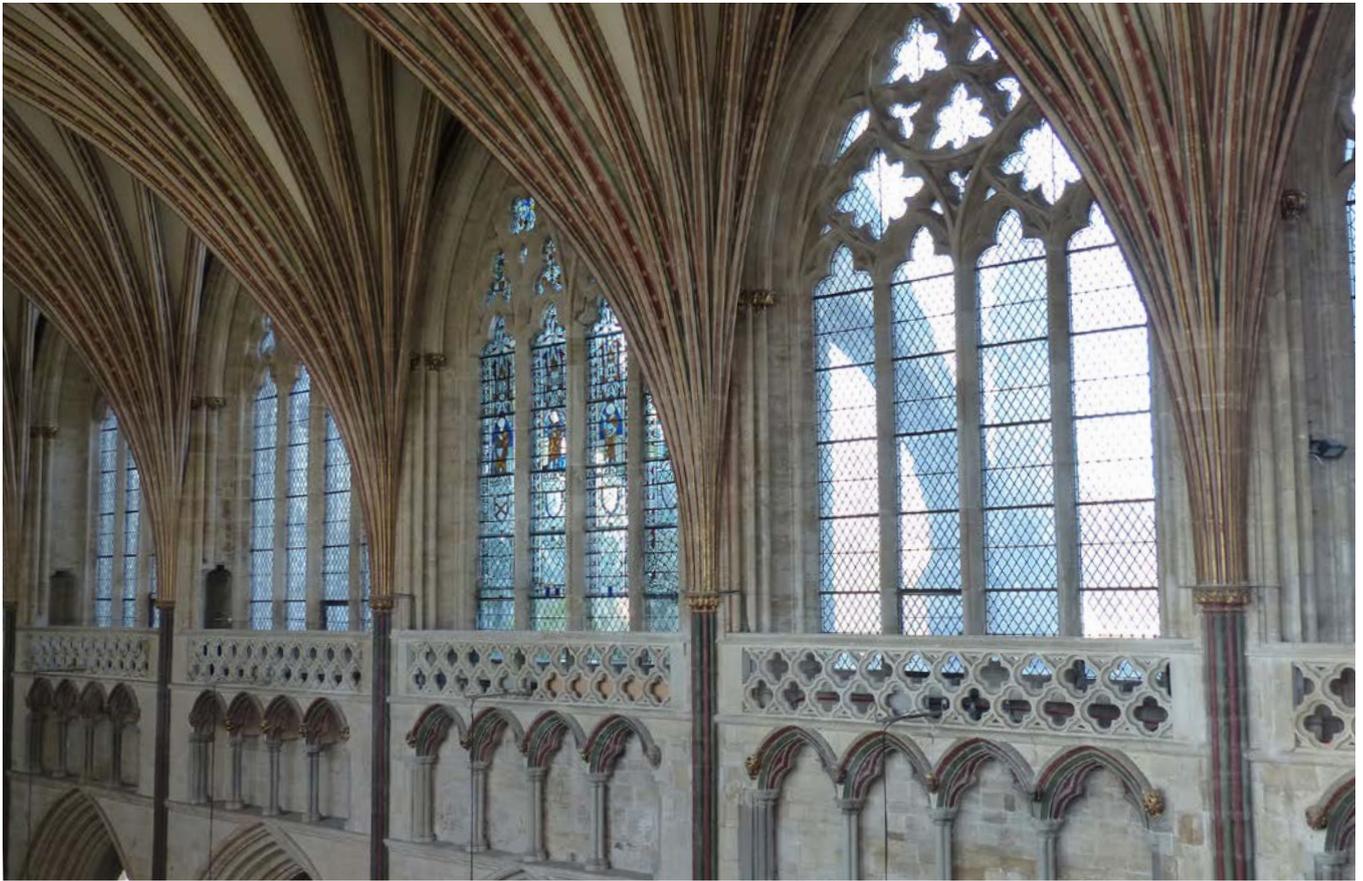
Figures 23–24: The impact of EPG on the interior must be weighed with great care. Here, at Exeter Cathedral, moving the stained glass in the north clerestory forwards out of its glazing groove would have taken it out of alignment with the plain glass in the neighbouring windows. It was judged to be less intrusive to bring the protective glazing outwards, particularly since on the exterior that window is partly hidden from view by a chapel.

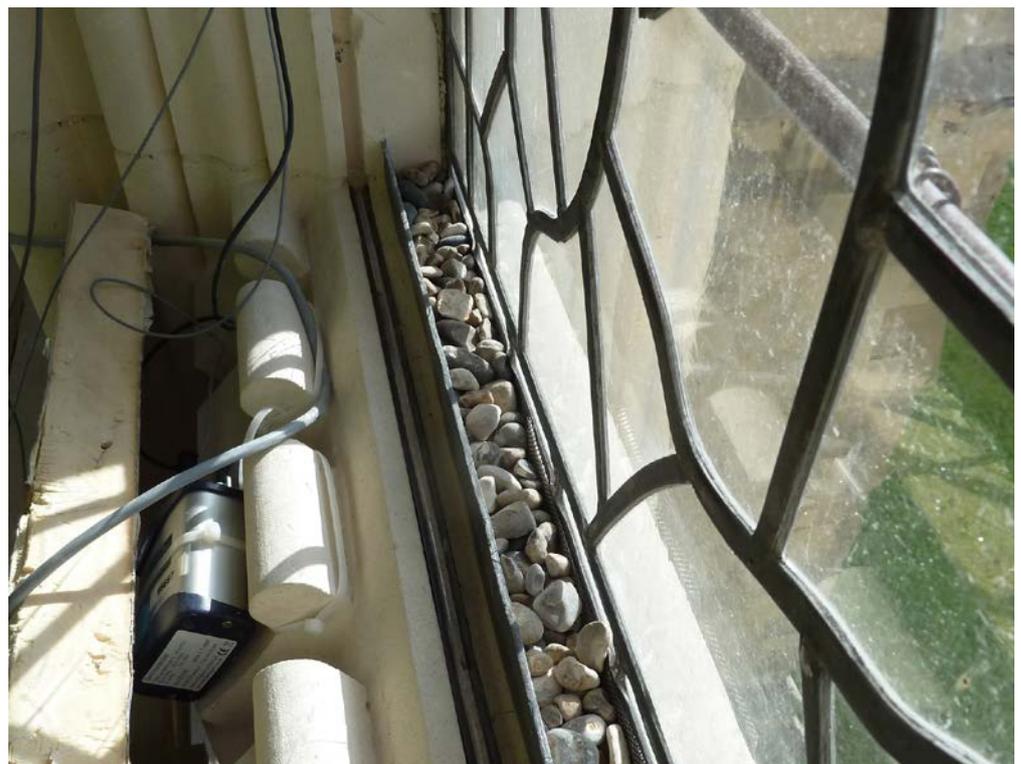
Figure 28: Here, a completed channel on the cill is shown with the protective glazing in place; the stained glass will be inserted into the groove in the window embrasure.

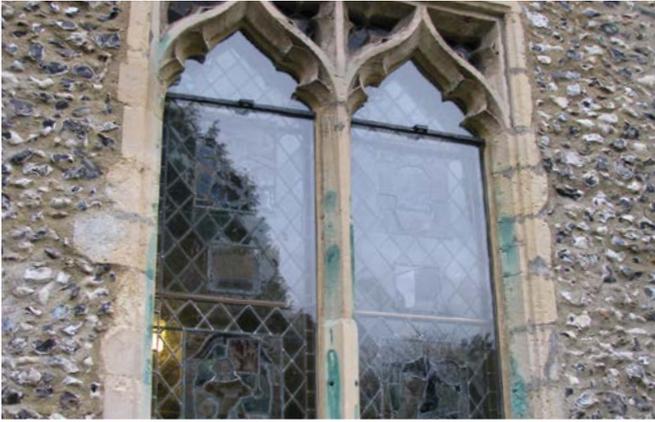
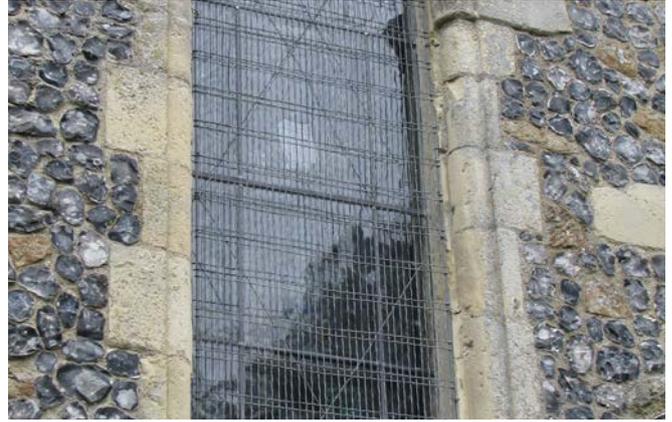
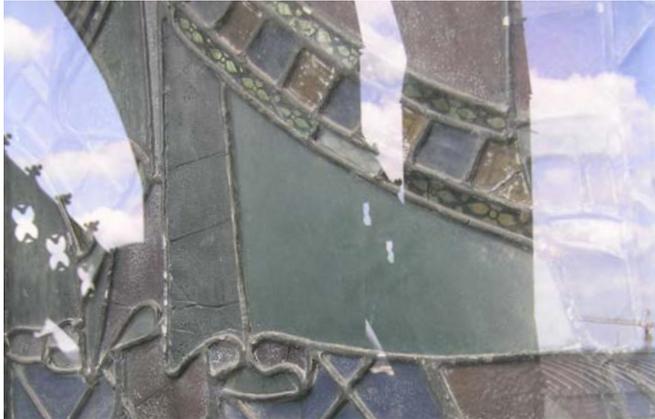
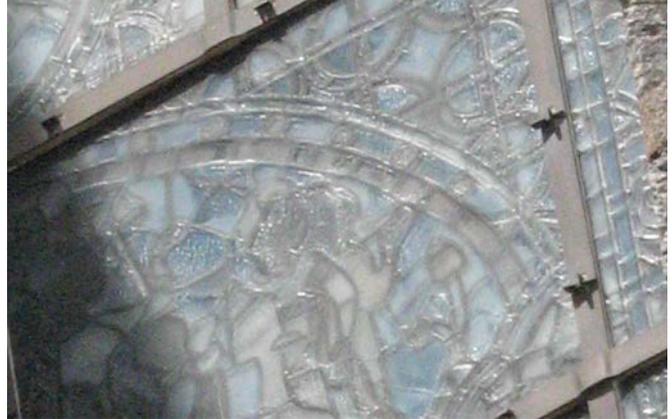
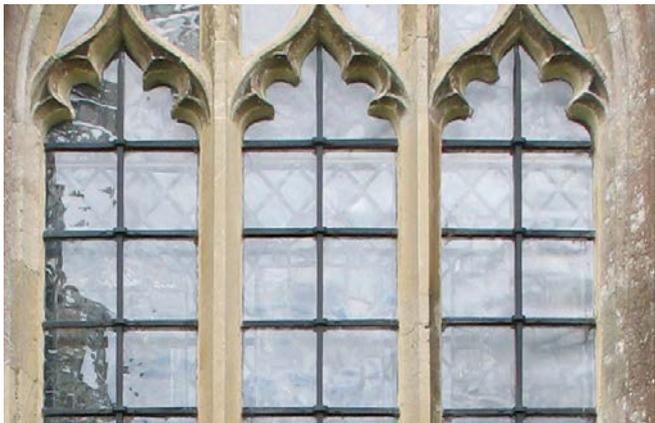
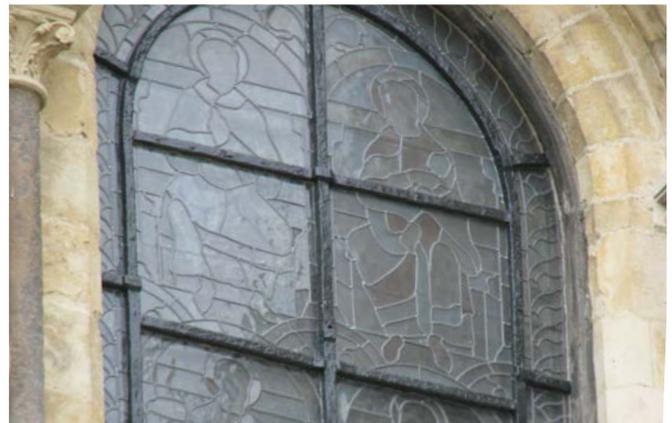
Figures 31–36: Modifying the exterior impact of EPG.

There are many materials and configurations that can be used to reduce the impact of EPG on the exterior views. The best choice will always depend on the particular location and window, and it is important to consider the impact on the interior view as well as the exterior. A great deal depends on how the protective glazing has been detailed.

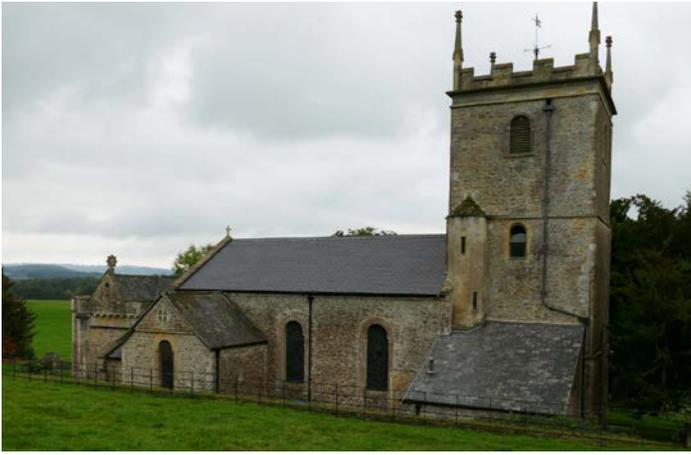
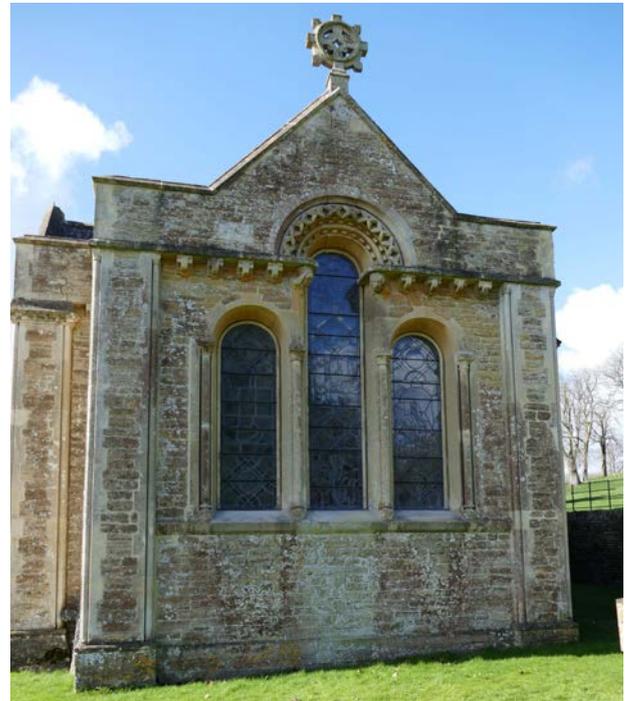
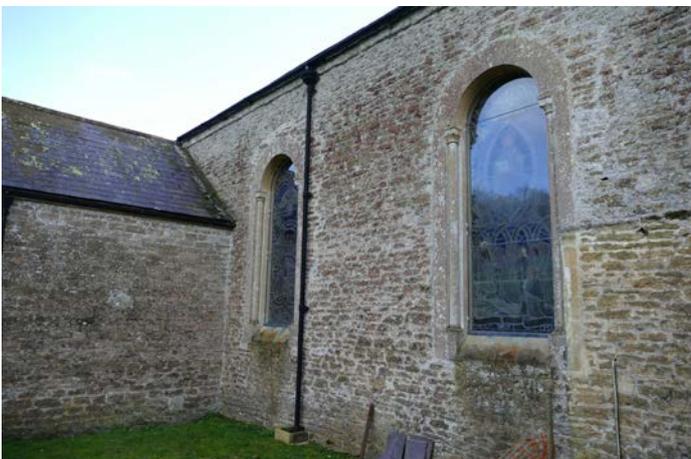
Figures 39–43: The optimum design of the protective glazing is case-dependent.

EPG design is so sensitive that, even on a small building, different elevations and even different windows may require different treatments. Here, at St Leonard's Church, Marston Bigot, Somerset (top left), the condition of the 1845 glass by Thomas Willement on the south side of the building – which had fewer and briefer periods of condensation due to solar exposure – was good apart from broken ties, and the windows could be left unprotected. The Willement glass on the north elevation, by contrast, was staying wet for long periods, and showed paint loss and severe algal growth (middle left). These windows and also the east window, which contains important glass collected from Flanders and the Rhineland (top right), urgently required the protection of EPG.

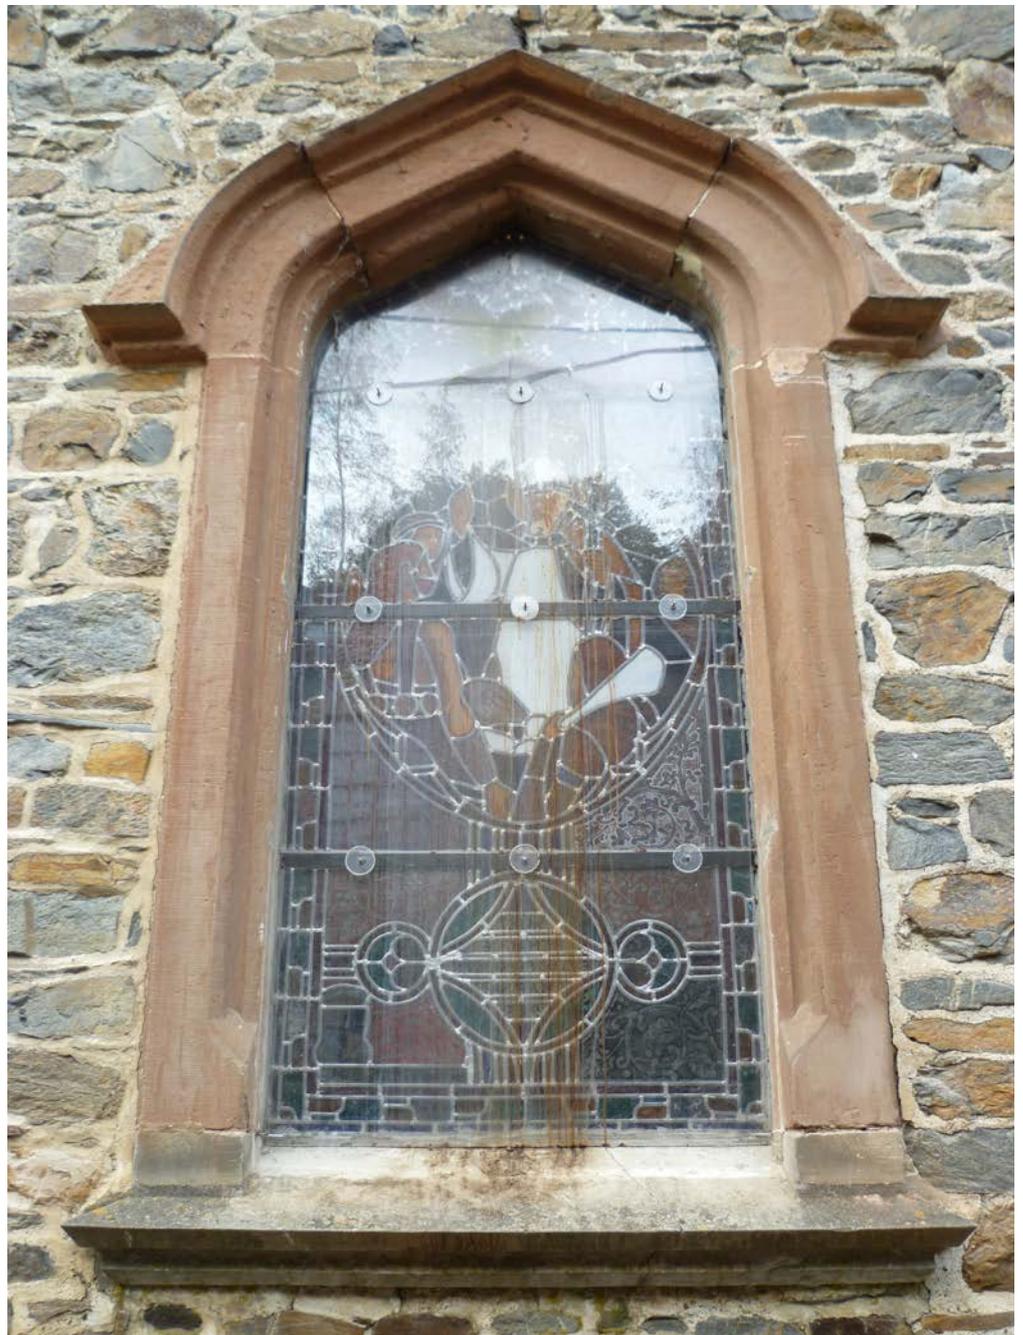
Figure 44: Insects such as wasps and spiders have been observed to nest in unventilated spaces between stained glass and protective sheeting (the cause of the staining shown here), but there may be some evidence that flying insects are discouraged by the airflow in the EPG interspace. This remains highly uncertain, however.
